## **Operational Assurance Team – Debrief Report**

Location & Address: Rankins Hall Farm, Stambridge Road, Stambridge, Rochford, Essex, SS4 2BF

Incident Type: Fire – Fire – Primary

Incident Number: 220613 – 24/12/2023

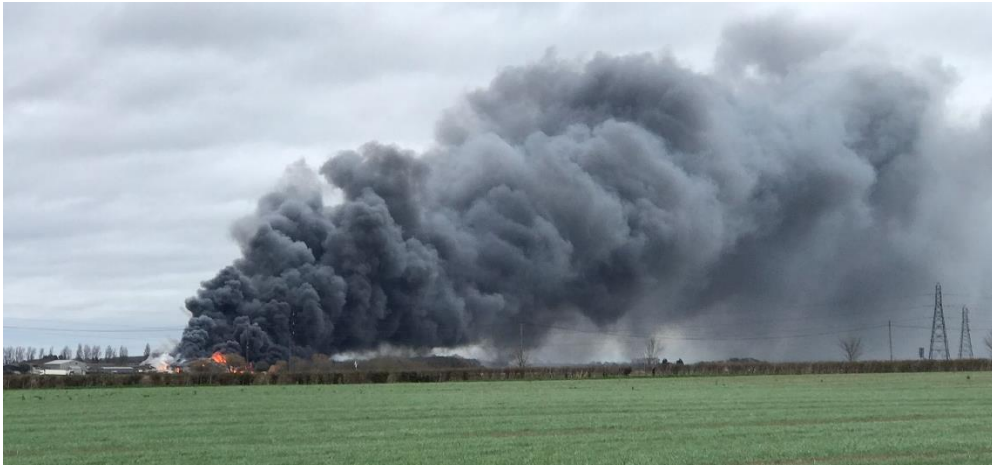
Image 2. Rankins Hall Farm

The first informative message from this incident informed Control that a large industrial site measuring 100m x 50m containing multiple units was 100% alight. Further to this Control was informed that 1 unit contained chemicals and 1 cylinders.

The Tier 2 investigation concluded that the fire was accidental and originated in a skip. The potential causes of the fire were noted as a chemical reaction, a malfunctioning/damaged battery or third-party interaction with the skip, potentially the introduction of waste from a log burner.
